MACNAIR
&
ASSOCIATES
CONSULTING ARBORISTS AND HORTICULTURISTS

September 19, 2015

RE: Malama Bahia Subdivision- Tree Inventory and Evaluation

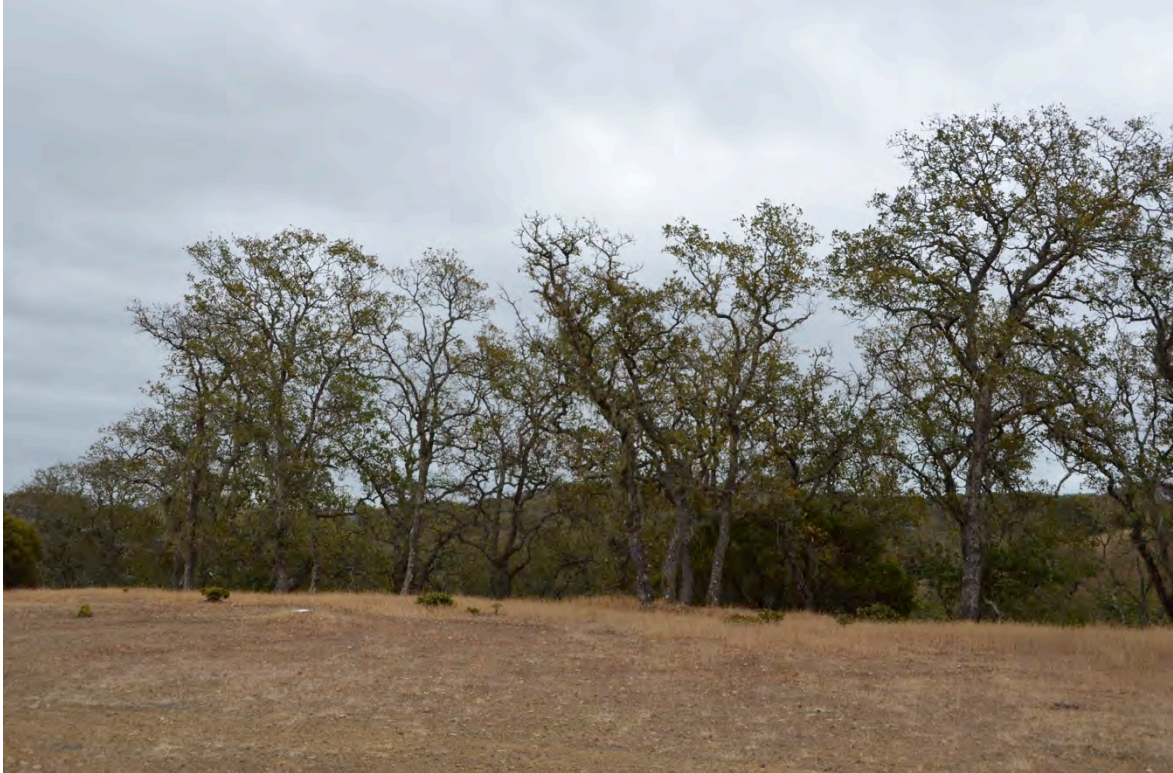
View of blue oak wood edge at rear of west building pad.

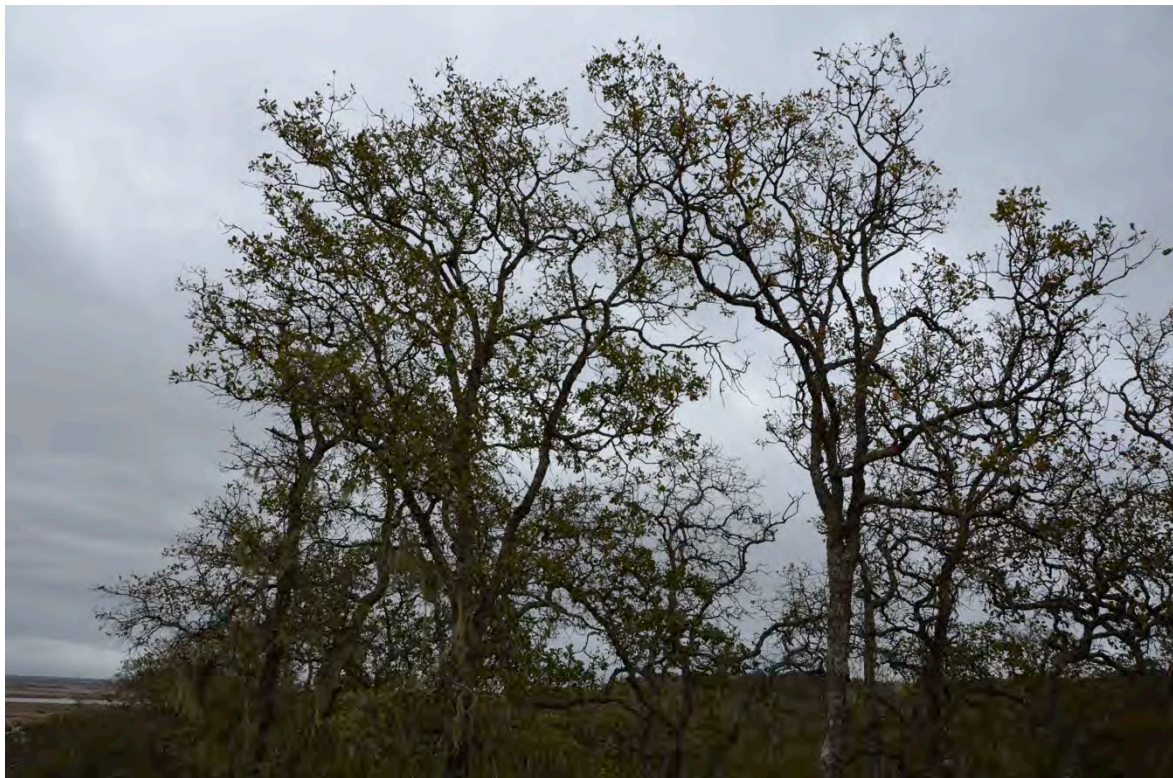
The blue oaks are significantly drought stressed with low vigor and branch/twig dieback occurring. Certain trees have structural defects relating to cankers and decay, but all typical of a blue oak woodland. The limited numbers of madrone are relatively young trees in moderately low vigor due to drought and limited infection by madrone canker (*Botryosphaeria spp.*).

Upper crowns of blue oaks with defoliation (early dormancy) and branch and twig dieback occurring from drought stress.

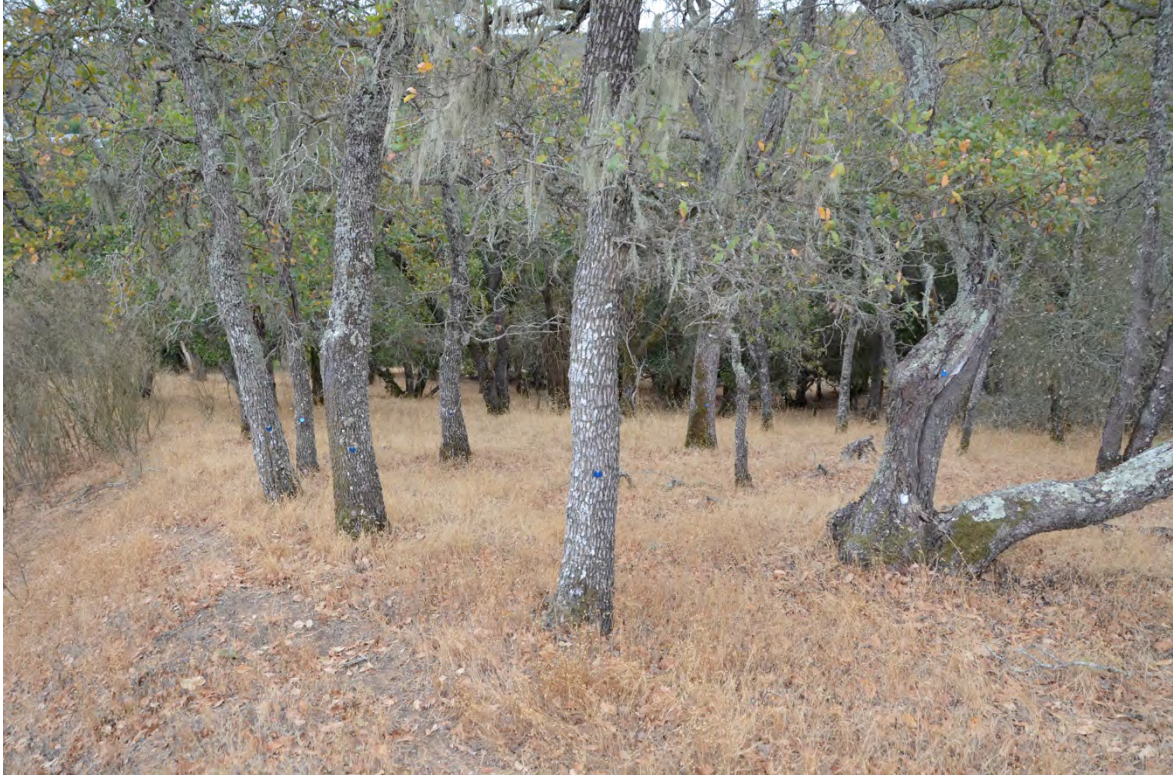
Blue oak woodland conditions behind west building pad.

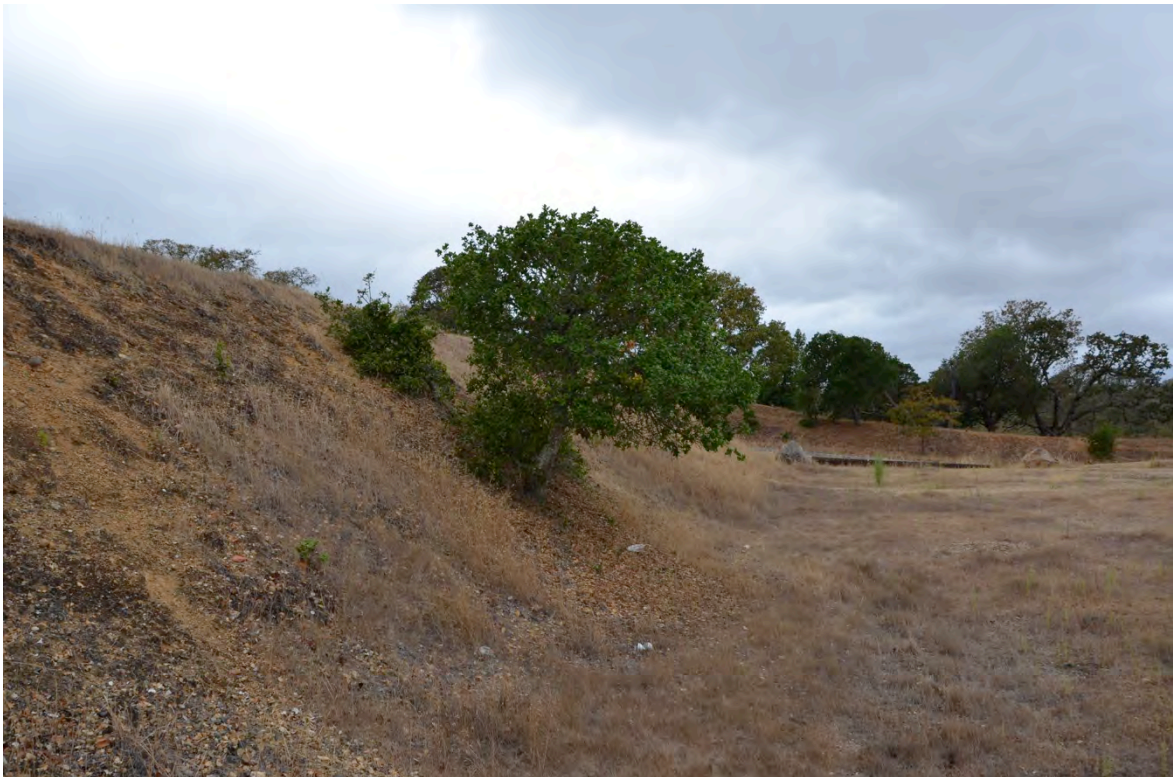
Solitary coast live oak growing on edge of cut slope.

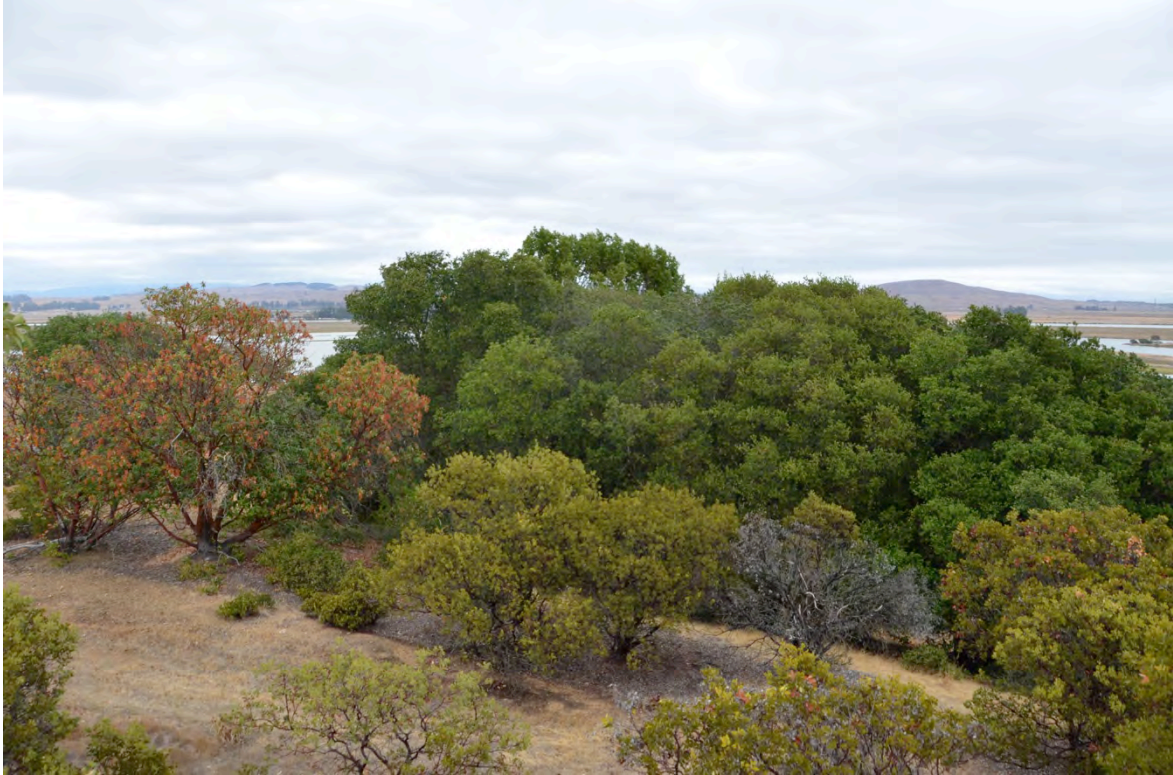
View from the west of coast live oak grove in central portion of the property. Two madrone are to the right.

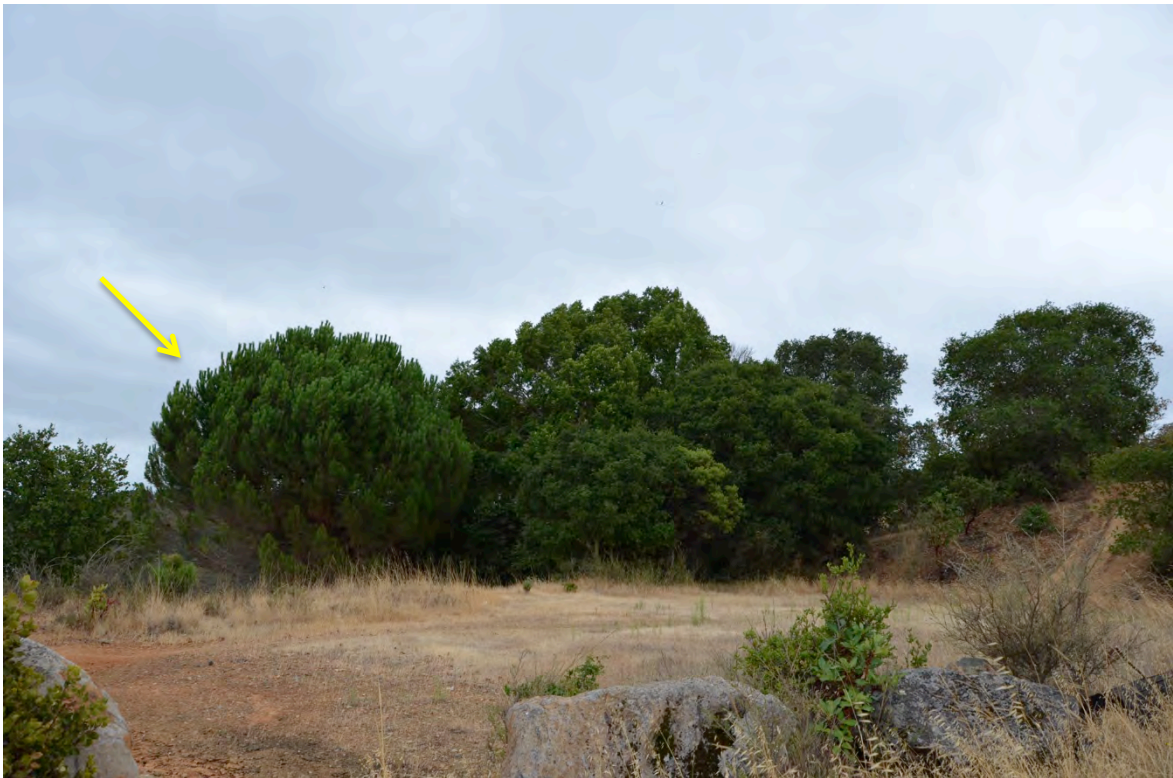
View of the coast live oaks and the mature Italian stone pine (arrow) from the north.

There is one mature non-native Italian stone pine in good health and numerous volunteer seedling trees of various ages. The mature pine and the volunteer trees are recommended for removal due to their status as a pyrophytic and invasive tree species.

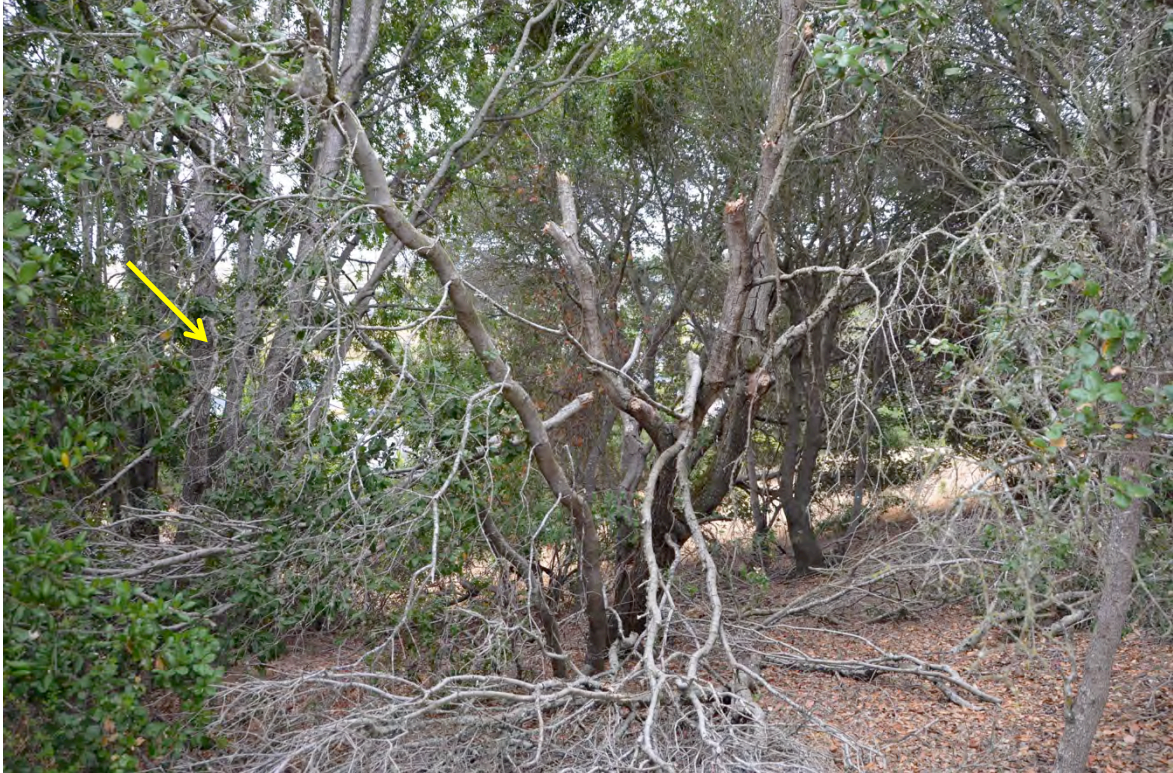
Tree conditions are variable. The bay laurels are in generally acceptable health, although structural conditions are marginal due to the multiple trunk structures. Bay laurels are the primary host for *Phytophthora ramorum* (SOD- Sudden Oak Death) and are located close to coast live oaks. For this reason, the bays are recommended for removal for protection of the remaining oaks. There has been tree mortality on the site due to SOD infection and at least one oak is symptomatic with trunk bleeding occurring.

Dead coast live oak killed by SOD infection. Mature bay laurel is to right (arrow). The three bay laurels growing within this grove are recommended for removal to prevent further oak losses.

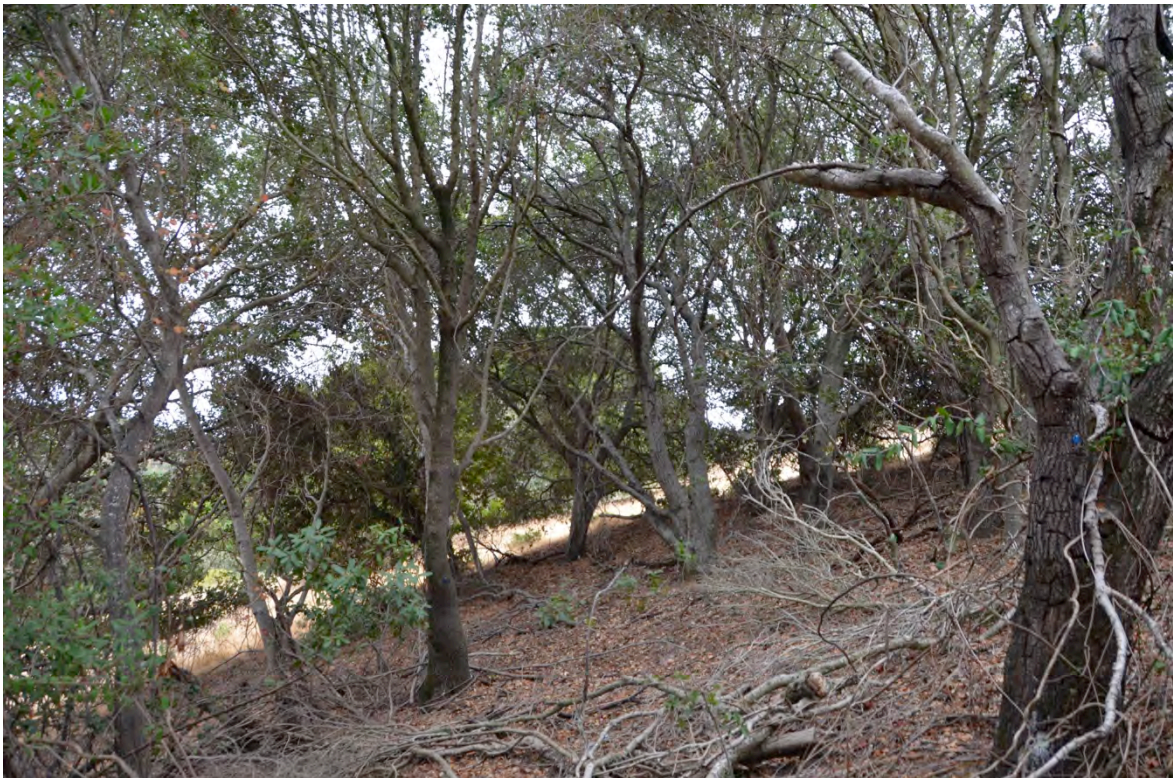
View of interior of coast live oak grove.

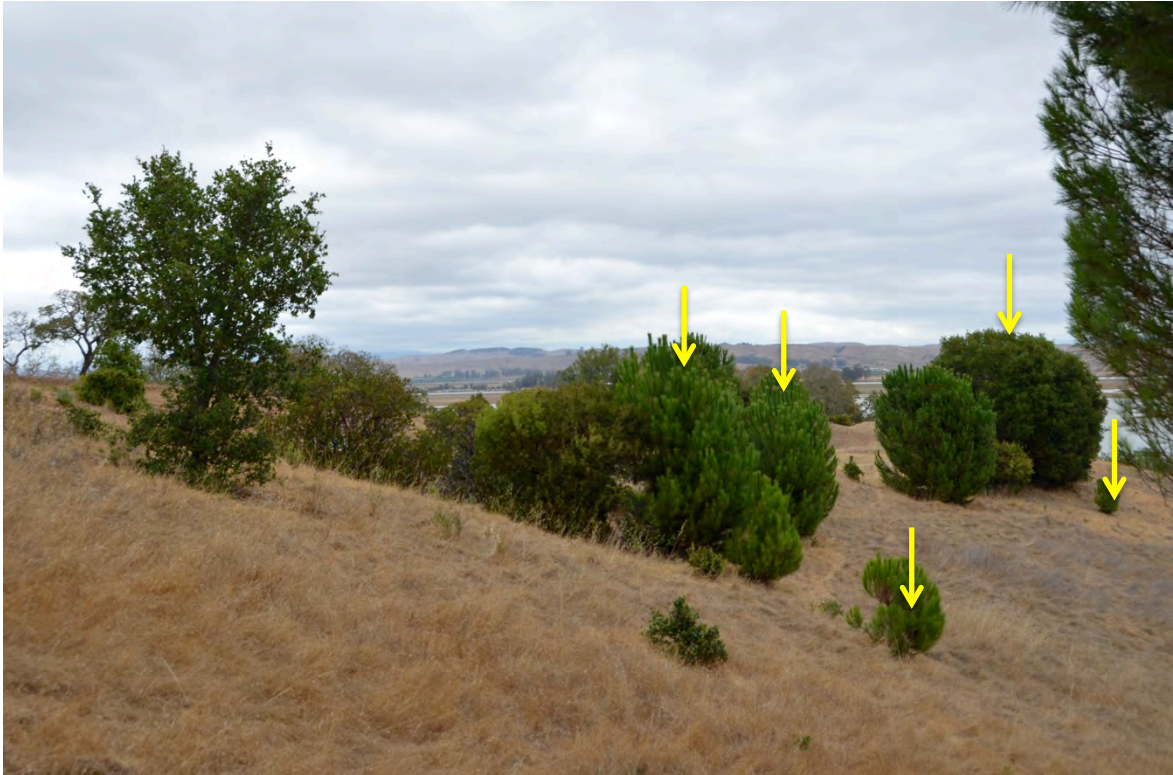
Numerous volunteer Italian stone pine seedlings are growing on the property. All are recommended for removal.

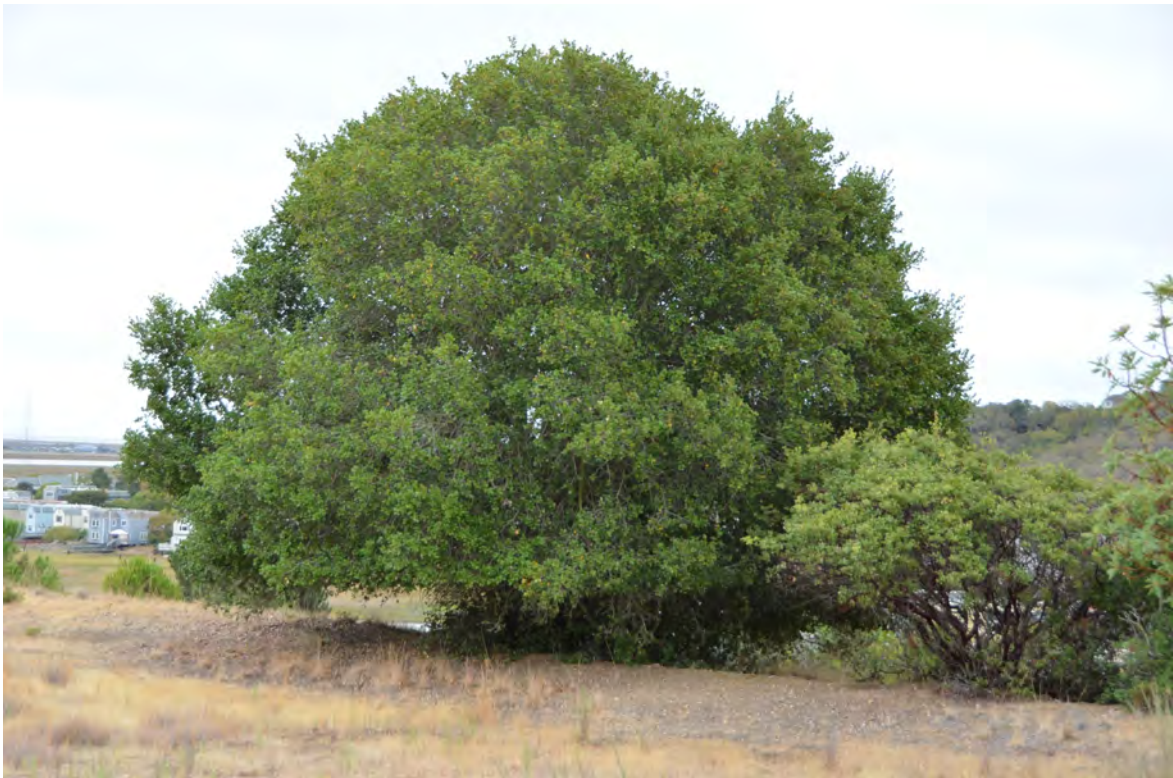
Semi-mature coast live oak located at edge of building envelope.
