January 31, 2024  
Project 2115

Re: **Geologic Hazard Evaluation Report**  
1110 Highland Drive  
Novato, California

# GEOLGIC HAZARD MAP

## 1110 Highland Drive Overview

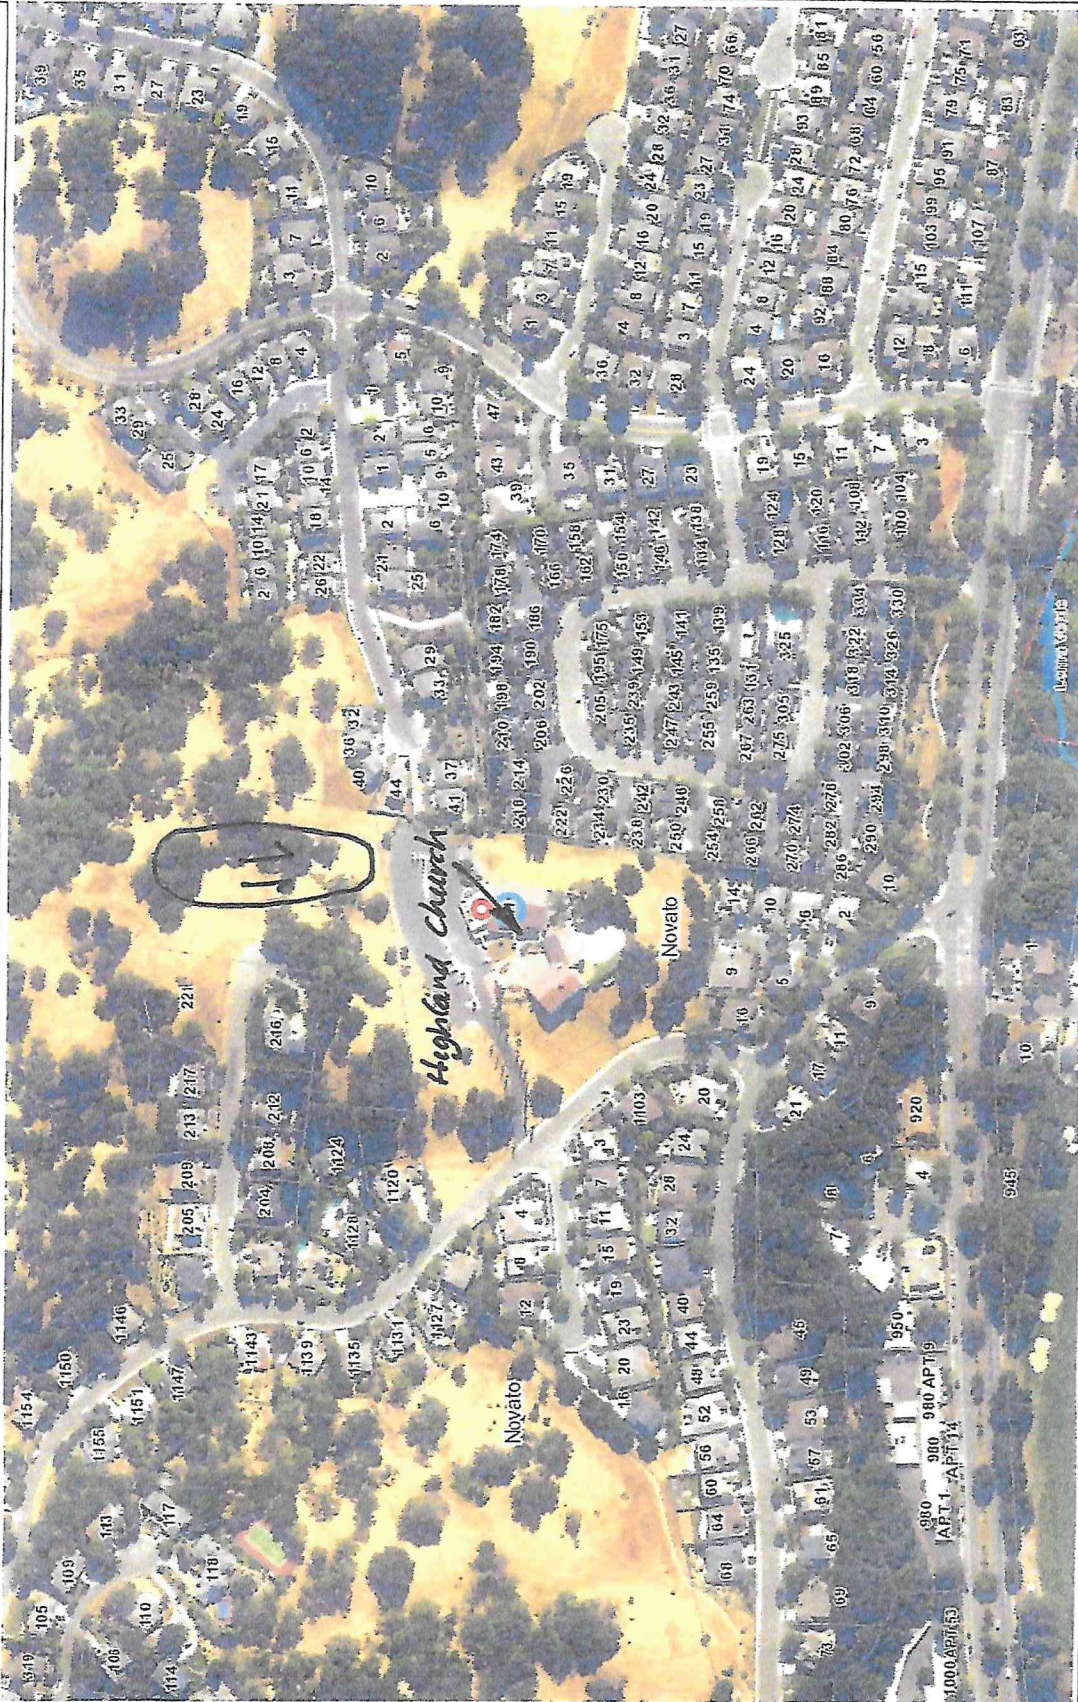
*Plate 1*

**0 - landside**

At your request, on 1/29/24, we performed a geologic hazard evaluation of the subject property at 1110 Highland Drive in Novato, California. The purpose of our work was to map and describe the potential impacts of geologic hazards to the subject property. Our Geologic Hazard Map is attached as Plate 1.

An approximately 130 foot wide by 370 foot long landslide exists offsite and upslope of the northeast corner of the parking lot. The feature does not display signs of recent landslide activity in the form of open ground cracks. However, hummocky irregular topography indicative of shallow surface soil movements in the past was observed. In our opinion, there is a risk of future landsliding resulting in downslope deposition of soil and rock. Such an event could damage the parking lot, requiring repairs and maintenance, and could require offsite mitigation in the form of engineered retaining walls or graded slope repairs.
